TCS Textile Consultancy Services

THE POLYURETHANE COATING ON THE INSIDE OF THIS JACKET HAS FAILED FOLLOWING A DRY CLEANING TREATMENT THAT IS FULLY COMPLIANT WITH THE REQUIREMENTS OF THE ATTACHED CARE LABELLING

Steven Pyott

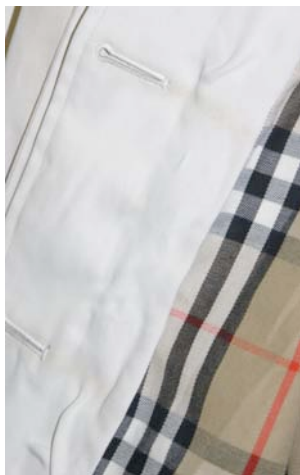
panels of its cream outer shell fabric. In addition, there was significant evidence of blistering, bubbling and puckering of the outer shell fabric, particularly along the lower hem of the jacket and on the inside of both the button and buttonhole panels.

Photograph 2.
Blistering Inside the Right Front

The main problems exhibited by this garment – the development of random blue and brown areas of staining throughout its outer shell fabric panels and extensive blistering and puckering of the outer shell fabric – strongly indicate that the coating on the inside of the outer shell fabric has become very adversely affected by its contact with perchlorethylene solvent in the course of the short dry cleaning treatment that was reported to have been used. The coating has partially dissolved in the perchlorethylene solvent to cause these problems.

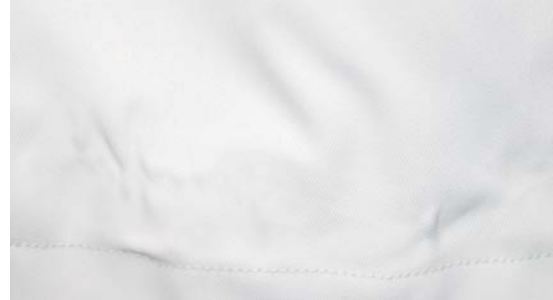
Photograph 3.
Blistering Above the Hem Area

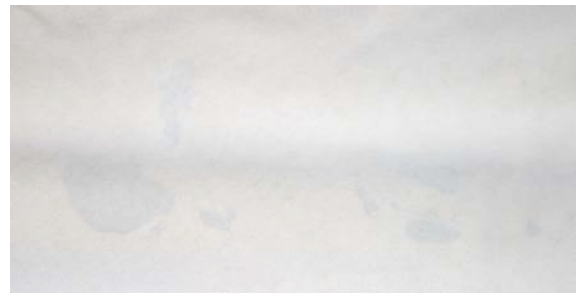
The structure of the cream outer shell fabric was examined by looking inside the seam allowance of the jacket's lower hem and it was found to consist of a cotton fabric which had been coated on its inside with a layer of white polyurethane. The jacket was examined on the outside under standard white lighting conditions and it was immediately apparent that numerous areas of blotchy blue and some light brown staining had developed in many of the

Photograph 4.
Fabric Discolouration Due to the Coating Failure

The problems of this jacket have been caused by a strongly adverse reaction between perchlorethylene solvent and the outer shell fabric's inner polyurethane coating. However, dry cleaning in perchlorethylene, with specified process restrictions, is the only method of care specified on the garment's care labelling and the dry cleaner has reported that the dry cleaning process used complied fully with these requirements.

Therefore, on the basis of all the available evidence, the manufacturer must accept responsibility for what has occurred with polyurethane coating in this jacket. The polyurethane coating appears to be unstable to even short exposures to perchlorethylene dry cleaning solvent. The garment should therefore be returned to the original point of purchase, along with a copy of this report, so that the customer can obtain appropriate redress for his loss.
