# Textile Consultancy Services Report

## CRUISE AUSTRALIA IMITATION SUEDE JACKET

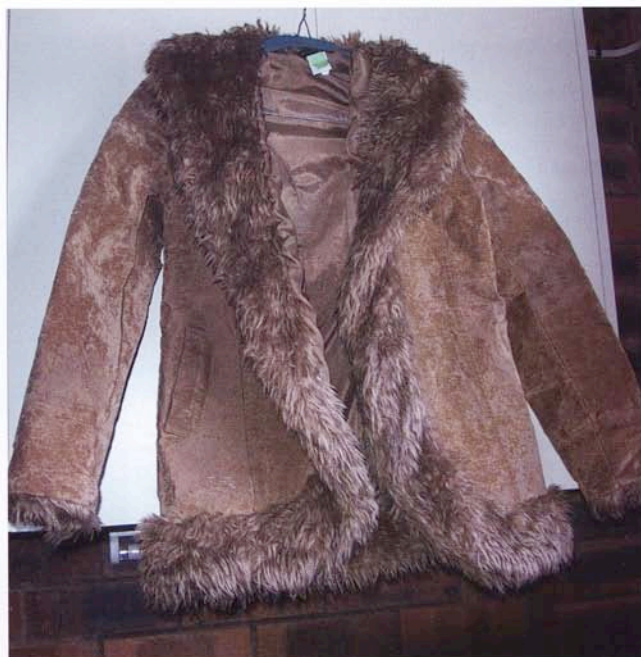
vinyl, which had a fabric backing. It was immediately apparent that there had been extensive loss of the synthetic suede coating and that the synthetic backing material onto which the imitation suede was attached had become completely stiff and brittle.

As a result of this brittleness, it showed evidence of cracking and splitting where the material had been folded.

This garment has lost much of its imitation suede coating and it has become unacceptably stiff and brittle, with resulting extensive cracking and splitting, due to the loss of plasticiser occurring during the course of a dry cleaning treatment that fully complied with the attached care labelling instructions "Dry Clean Only". This care label permits no other method of cleaning and the dry cleaner is entitled to assume the care labelling is correct and has no prior way of knowing whether or not a garment is likely to be damaged by the dry cleaning process.

to give the material suppleness and pliability so that the garment will be comfortable for the wearer. Unfortunately, the perchlorethylene solvent, which has been applied to this garment in the course of dry cleaning has caused the loss of the plasticiser from the backing material resulting in its dramatic change of texture and cracking damage.

CRUISE AUSTRALIA IMITATION SUEDE JACKET

The responsibility for this situation must therefore lie with the manufacturer and the garment and a copy of this report should be taken to the point of purchase so that the customer can receive appropriate redress for this loss.
