# **TCS Textile Consultancy Services**

**THE FUSIBLE INTERFACING USED TO PROVIDE BODY TO THE FRONT PANELS OF THIS GREEN AND WHITE JACKET HAS FAILED FOLLOWING A SECOND ACCEPTABLE DRY CLEANING TREATMENT**

**Report prepared by**

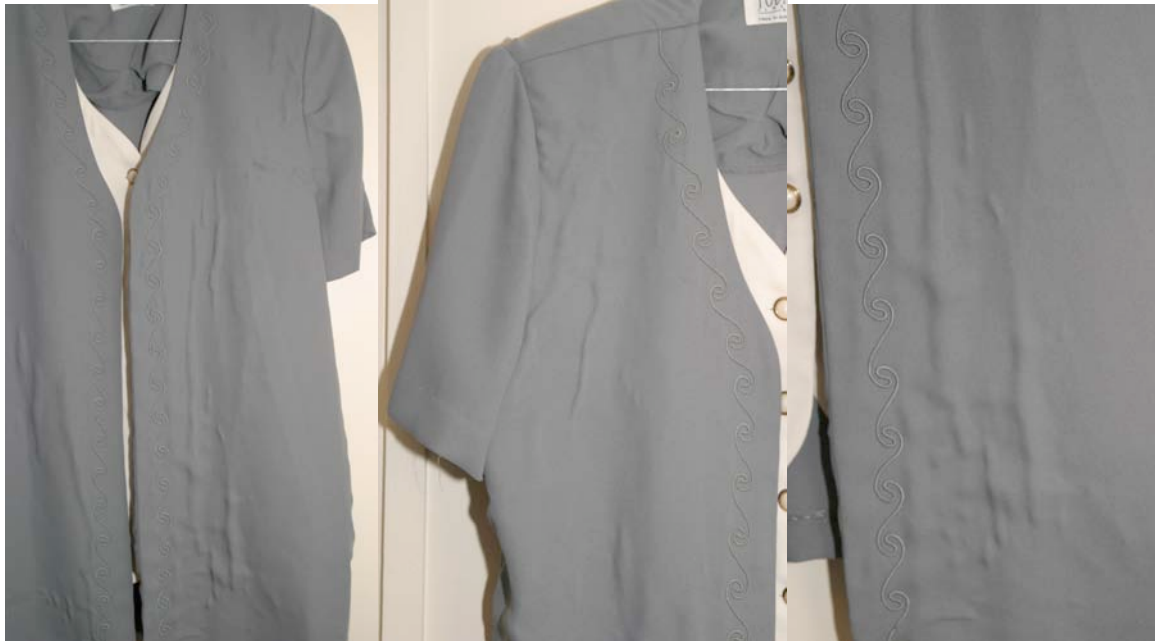
The garment was examined under standard white lighting conditions and it was immediately evident that there was extensive blistering or bubbling of the green outer shell fabric throughout both the front panels, as well as on the upper rear inside panel below the neck, that runs across the top of the shoulders. It was noted that all these panels had a black fusible

interfacing fabric attached to the back of them and that this extensive blistering effect was due to this interfacing becoming partially separated from the shell fabric.

**Various Views Of The Front Of The Garment Showing The Blistering Or Bubbling Effect Caused By The Failure Of The Fusible Interlining**

The fusible interfacing used in this garment has become extensively separated from its shell fabric as a result of a dry cleaning process that complies with the requirements of the garment's care labelling. The responsibility for this situation clearly lies with the manufacturer and the garment, along with a copy of this report, should be returned to the original point of purchase so that the customer can receive appropriate redress for her loss.

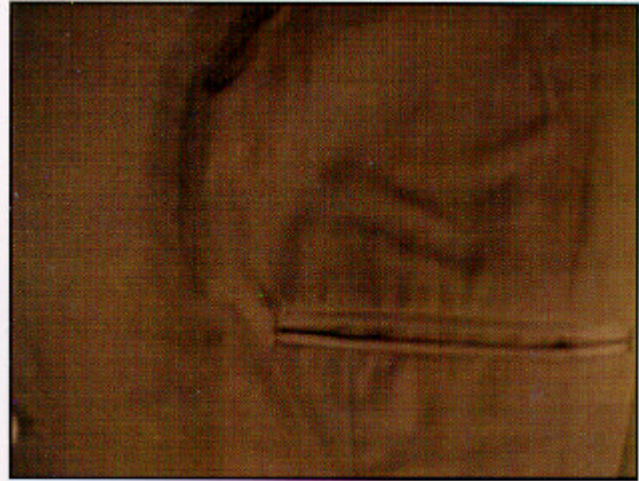
The interfacing material may lack resistance to wear and cleaning procedures because of insufficient time, temperature, or pressure used in the original fusing process during manufacture. Also, not all fusibles are completely compatible with all shell fabrics. In some cases, there may be different rates of relaxation shrinkage between the two materials.

*The fabric of this jacket appears blistered because the fusible was pulled apart from its shell fabric.*

In some cases, the professional drycleaner can attempt to re-fuse the separated fabrics together by extensive finishing procedures. However, this process cannot be safely used on all fabrics without causing objectionable shine, seam impressions, or, in some cases, distortion.
